## Rock-Fall Hazards

William F. Case, Utah Geological Survey

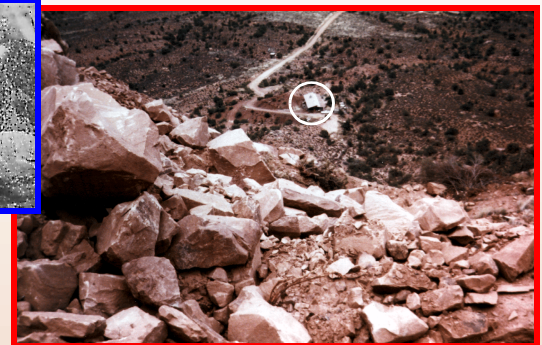
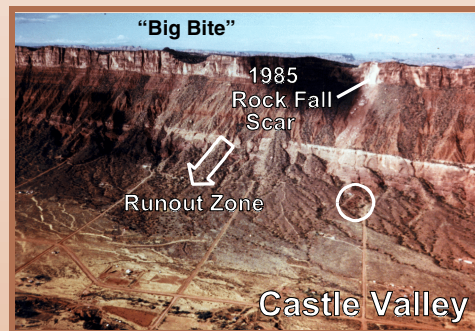
At approximately 7 a.m. on July 8, 1985, 48,000 cubic yards of rock fell from Porcupine Rim, Grand County, barely missing an unoccupied house (circled) in the

community of Castle Valley. Dust entered open windows and covered the interior to a depth of an inch. The largest rock fall boulder in the runout zone was 50 X 15 X 15 feet. The triggering mechanism for the rock fall is unknown; it may have occurred when the night-cold, east-facing cliff was

warmed by the intense morning sun. Other recent rock falls show as light-colored scars elsewhere on the face of Porcupine Rim and as relatively vegetation-free, light-colored rock-pile slopes (talus) below the scars. Geologically older rock-fall scars and their deposits are darker and have more vegetation relative to the amount of time since the event. The scar at the "big bite" was produced by a rock fall witnessed in October 1978. Buildings constructed below the rim in the runout zone are in harm's way.

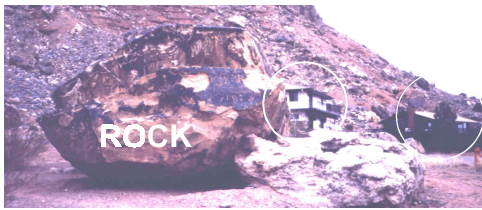
Homes (circled) in rock-fall runout zone, Bloomington, Washington County

Rock falls and slides are a threat to property and life within the runout zone. The runout zone extends from the slope below the source downward to at least the maximum distance from the cliff that rocks have fallen and rolled.

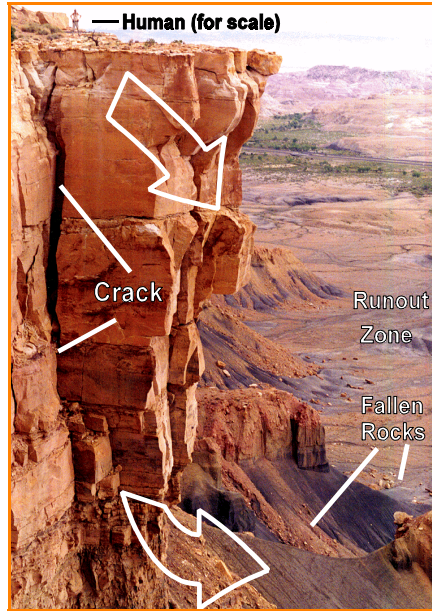
Future rock fall, and runout zone of past rock falls, Emery County. Michael D. Laine.

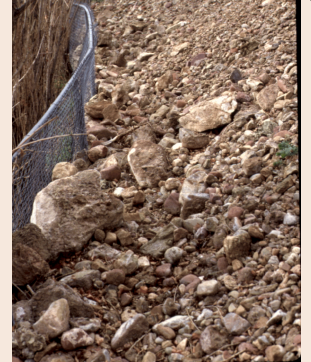
Chain-link fence protection.

Chain-link fences offer protection from local, small rocks. Gabions or Jersey barriers also provide protection from rolling rocks.

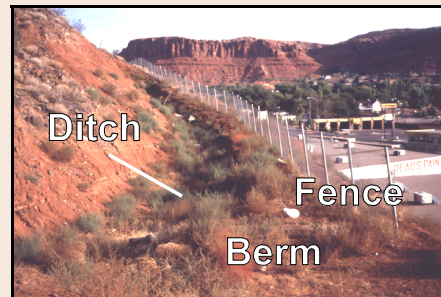
Ditch, berm, and chain-link fence for rock-fall protection, Bluff Street, St. George.

Rolling boulders can be trapped in a ditch with a berm to prevent them from bouncing out.

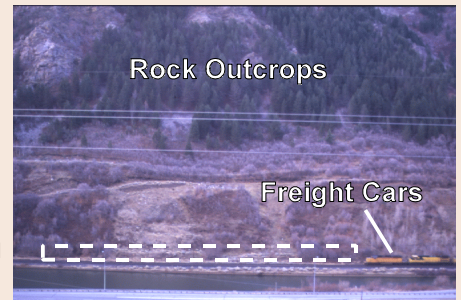
Alarm fence (dashed area) along railroad track, Weber Canyon, Weber County. Rich Giraud, UGS.

Railroad tracks can

be monitored for landslide, including rock-fall, damage with wire sensors that sound an alarm when they are hit.

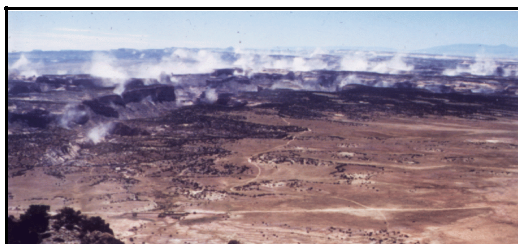
Dust produced by simultaneous rock falls triggered by a magnitude 5.3 earthquake in Emery County. Terry A. Humphrey, Bureau of Land Management.
